INSPECTION REPORT

1234 Sample Street
Tucson, AZ 85701

1/30/2008

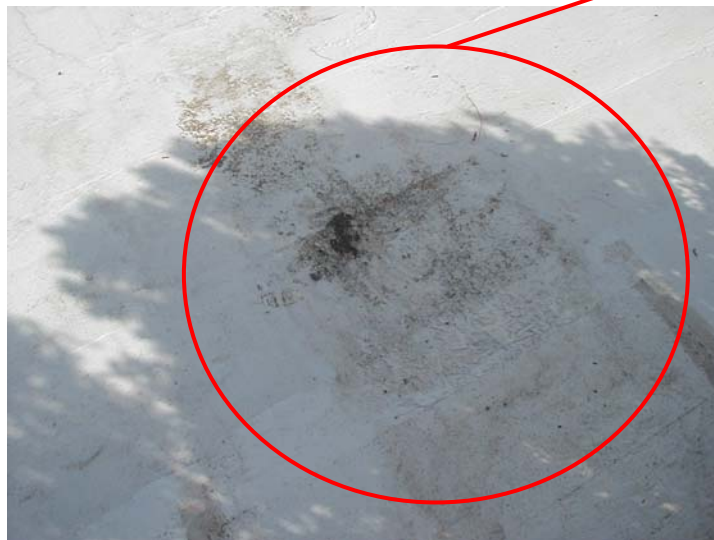
<u>ITEM</u>	<u>CODE</u>	<u>REMARKS</u>
<u>ROOF CONDITIONS</u>	RNF	<u>R.2B Coatings</u> : Surface coating is needed. An application of reflective coating is needed every two to four years as normal maintenance for this type of roof. Elastomeric coating is recommended.

RC.1 Surface Coating Needed

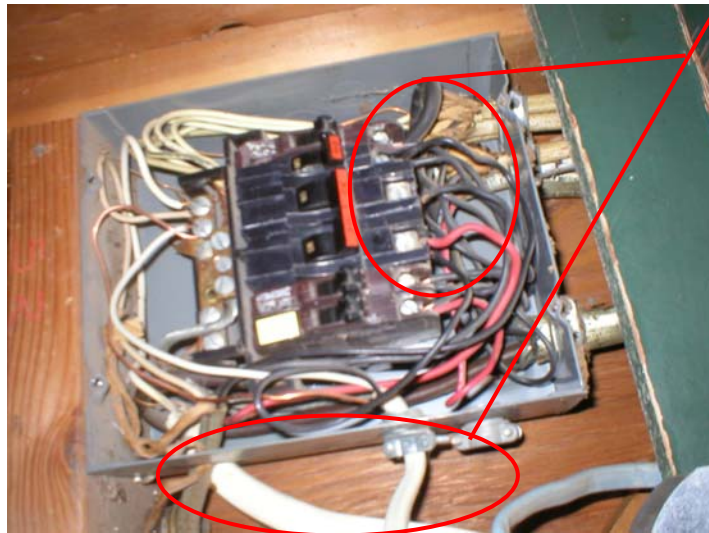
Electric: Double-tapped breakers are present at the sub-panel; recommend installation of additional breakers and further evaluation/repair by a licensed electrician. (Safety Hazard) Also, surface mounted exposed Romex wiring requires encapsulation (conduit) at the sub-panel.

U.1 Double-Tapped Breakers & Surface Mounted Romex Wiring
